## **WORLD CLASS OVER-HEIGHT VEHICLE DETECTION/WARNING SYSTEMS - WHY DO DRIVERS CRASH? A HUMAN FACTORS PERSPECTIVE**

Presenter: Jo Chang, MSc Human Factors, Member of IPENZ Transport Group. Human Factors Specialist/Transport Planner, Opus International Consultants Ltd, joanne.chang@opus.co.nz

Presenter: Russell Pinchen, MSc, Advanced Technologies in Electronics, Senior Intelligent Transport Systems Engineer, NZ Transport Agency, Russell.Pinchen@nzta.govt.nz

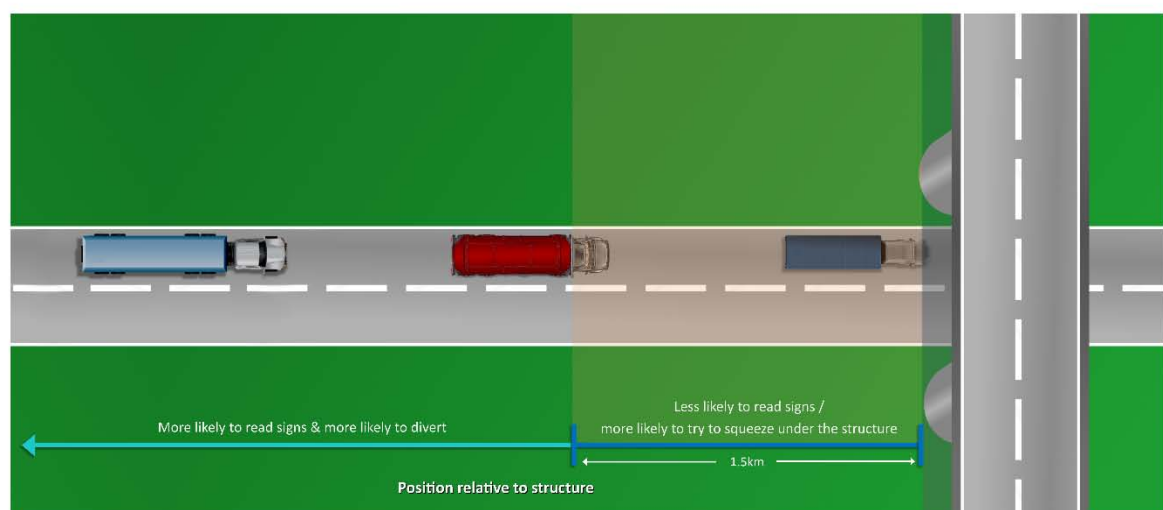
Figure 1: Compliance Risk to Counter-measures versus Distance to the Structure

These factors have the following design implications for designing an over-height detection warning system:
